Manhole Inspection Summary

Manhole # S33UU_002MH

Insp Date: **4/17/07 9:15 AM**

Location Address: **19 29TH ST**

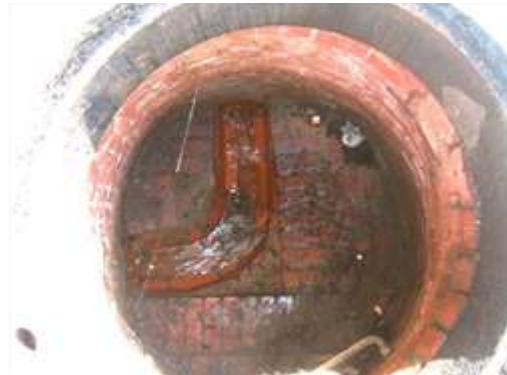
Top View

Corroded steps. Evidence of surcharge - Bench debris.

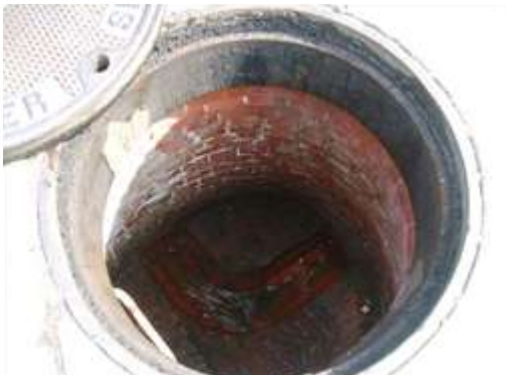
Defect

Frame Offset: **0** (in.) Condition: ☐ Sound ☐ Cracked ☒ **Leaks**

Infiltration: ☐ None ☒ **Joint** ☐ Cracks ☒ **Mortar** ☐ Roots ☐ Wall

Frame leaks. Corbel and Barrel infiltration.

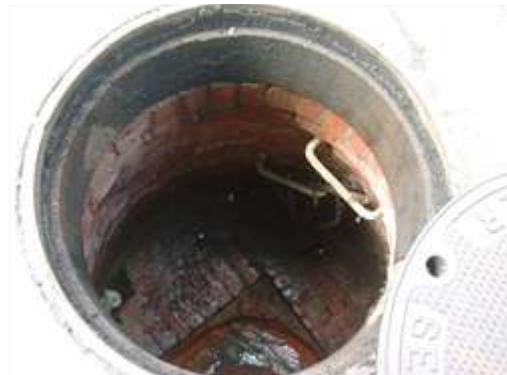
Defect

Condition: ☐ Sound ☐ Cracked ☐ Root Intrusion ☐ Loose Brick ☒ **Deteriorated**

Infiltration: ☐ None ☐ Joint ☐ Cracks ☒ **Mortar** ☐ Roots ☒ **Wall**

Frame leaks. Corbel deterioration and infiltration. Barrel infiltration - other side.

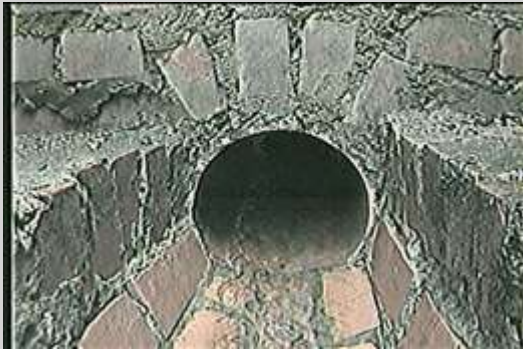
8 in. Circular Gravity Sewer
Pipe Out @ 12 O'Clock

Pipe Material: **Clay** ☐ Pipe Lined

Invert Depth: **6.36** (ft.) Flow Characteristics: **Slow**

Infiltration: **None** Pipe Seal Cond: **Unknown**

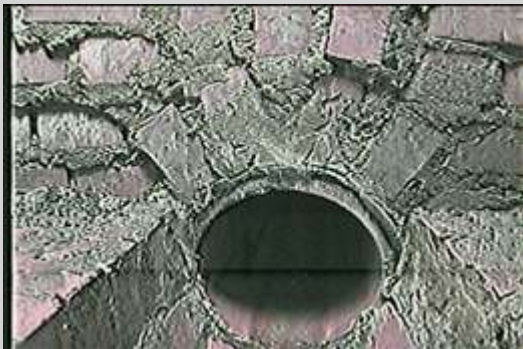
8 in. Circular Gravity Sewer
Pipe In @ 9 O'Clock

Pipe Material: **Clay** ☐ Pipe Lined

Invert Depth: **6.14** (ft.) Flow Characteristics: **Slow**

Infiltration: **None** Pipe Seal Cond: **Unknown**
